Rehabilitation of the vertical dimension with fixed and removable prosthesis: Case Report

This clinical case report describes the management of a 50-years-old female patient with a worn out anterior upper teeth opposing mildly attrited anterior lower teeth with a loss of maxillary and mandibular posterior teeth.

The case was treated by restoring the lost of vertical dimension by prosthetic rehabilitation.

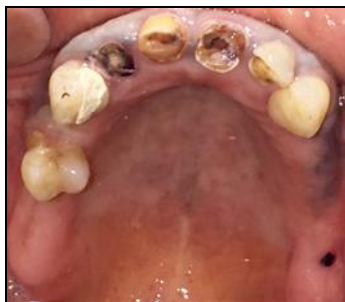
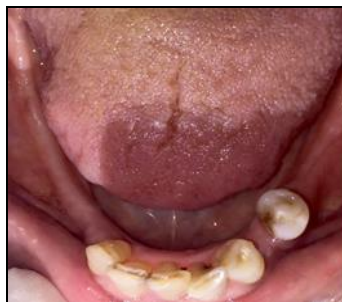
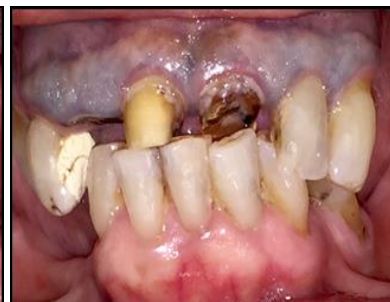
Intra oral examination reveals worn out anterior teeth, partially edentulous maxillary and mandibular arches with reduced VD [Figure 1, 2, 3]

Fig 1: upper view

Fig 2: lower view

Fig 3: frontal view

VD rehabilitation of the mouth was planned to restore the function, esthetics, speech, and comfort of the patient.

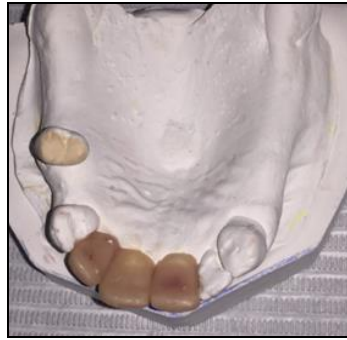
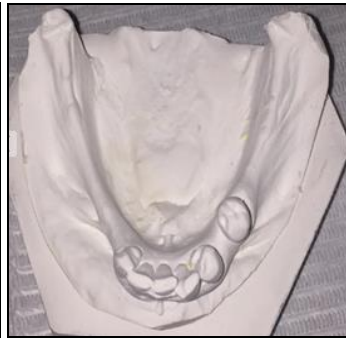
2. Removal of the retained root stump of #12, 27 was done, after the healing of the extracted site, the patient was taken for the prosthodontic procedures.
3. Maxillary and mandibular impressions were made with irreversible hydrocolloid impression material and diagnostic casts were made for execution of the treatment plan. The cast were analyzed, diagnostic wax-up was performed (figure 4,5)

Fig 4: upper cast

Fig 5: lower cast

The assessment of vertical dimension was done and accordingly a removable partial denture was fabricated and the patient was instructed to wear it for 4 weeks to improve the (VD) and TMJ discomfort

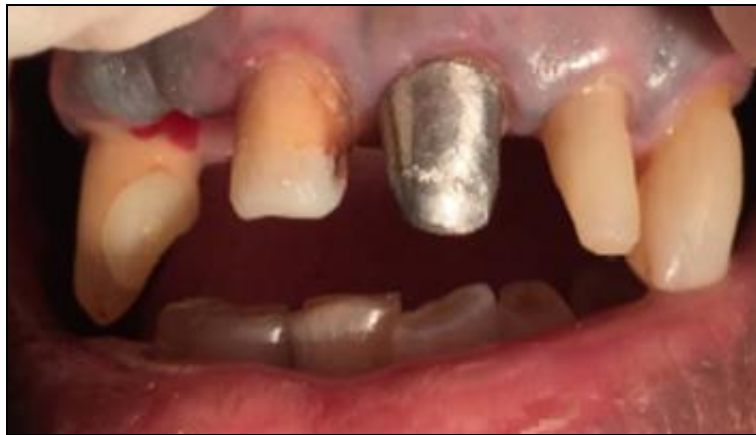
4. The Root canal treatment was carried out in maxillary anterior (13, 11, and 21).
5. then the casted post was fabricated and then cemented in #21 (figure 6)

Fig 6: cast cementation

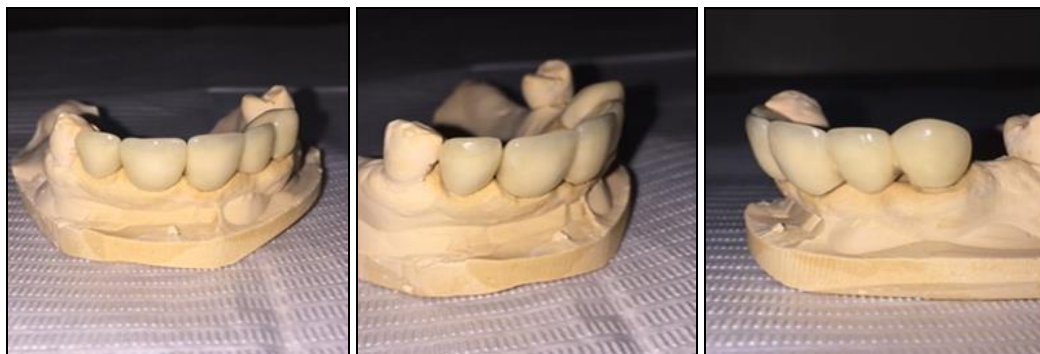
7. In laboratory, wax patterns were invested and casted in metal ceramic prosthesis (figure 7). All the bridge and crown were then cemented.

Fig 7: Metal Ceramic Prosthesis

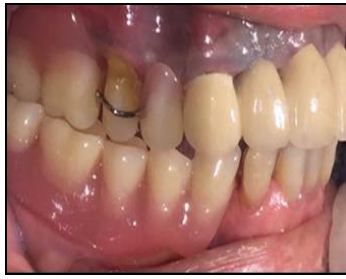
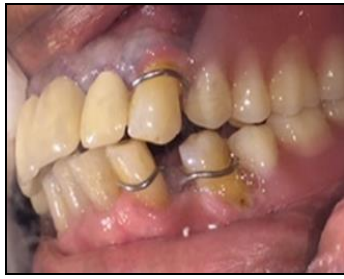
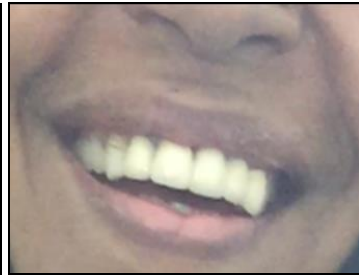
8. Finally the occlusion was checked and selective grinding was performed intraorally. Oral hygiene

Instruction were given and regular reviews were scheduled. (Figure 8, 9, 10)

Fig 8: Right side

Fig 9: Left side

Fig 10: final smile

This case reports that a satisfactory clinical result was achieved by restoring the vertical dimension with an improvement in esthetics and function.
