## A case report on rehabilitation of fractured maxillary anterior teeth using custom cast post and core and pre-fabricated fiber post and core

This article reports a case of upper anterior teeth which were endodontically treated and rehabilitated using custom made cast post and core and pre-fabricated fiber post and core, followed by full coverage crowns.

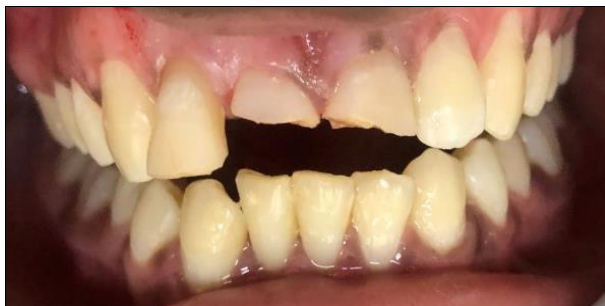
Fig 1: Pre operative clinical view

A 21-year-old male patient came to the Department of Conservative Dentistry and Endodontics, with a complaint of fractured upper front teeth and wanted to get that treated. The patient gave of history of accident six months back. (Fig 1) On intra-oral examination, complicated crown fracture was noted in relation to 11 and 21. Mild extrusion and discolouration of 12 were also noted. On examination, there was no pain and swelling. A vitality test of 12,11 and

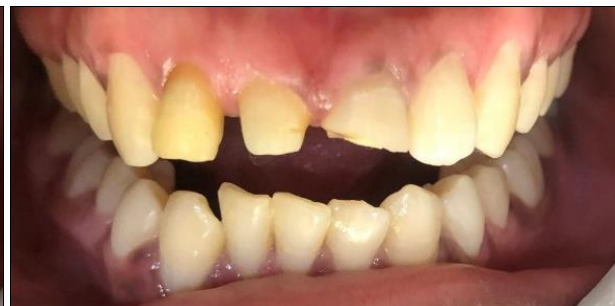
Fig 2: Fibre post and core on 11

Post-space preparation of 11 was done using peeso reamers size 2 leaving 5mm apical gutta-percha intact for apical seal. The root canal dentin walls were etched with 36% phosphoric acid for 15 seconds. The acid was then removed with water sprayed for 20 seconds and the root walls were carefully dried with absorbent paper points prior to bonding procedures. Prefabricated post was cleaned with alcohol. Self-adhesive resin cement (RelyX U200, 3M ESPE, Germany) was introduced into the root canal space with an intracanal mixing tip and the fiber post was seated. Excess resin cement was removed, and the remaining cement was light-cured for 20 seconds to ensure adequate polymerization of the cement. The material excess was removed with diamond bur and a periapical radiograph was taken to confirm the fiber post adaptation and root sealing. The core build-up was done using composite and the tooth was prepared to receive a zirconia crown (Figure 2). A two-step putty-wash impression with polyvinyl siloxane was performed. The crown was luted with self-adhesive resin cement (RelyX U200, 3M ESPE AG, Germany). (Fig 3a) On next appointment obturated material was removed from the tooth 12 up to 2 mm below the cemento-enamel junction. Stains in the pulp chamber were removed using round bur with the minimal destruction. After removal of the gutta percha and stains, a 2 mm glass ionomer cement (Type 2, GC Corporation, Singapore) was placed over the gutta-percha as a barrier material. Using 37% phosphoric acid, pulp chamber was etched for 30-60 s, washed and dried, which resulted in the opening of dentinal tubules.

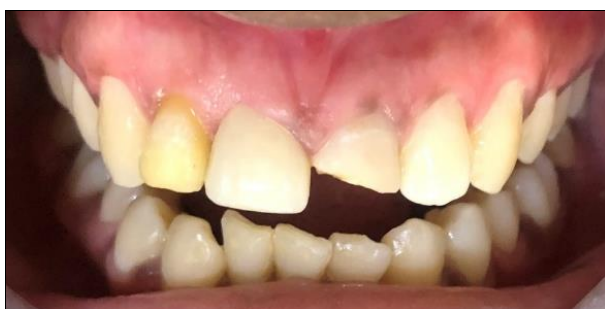
Fig 3a: Before non-vital bleaching of 12

21 was done with electric pulp tester and the cold test, and did not show any response. Radiographic examination showed fractured 11 and 21 with pulp involvement and well-defined periapical radiolucency in relation to 12. On thorough clinical and radiographic examination, a diagnosis of asymptomatic apical periodontitis in relation to 12 was made. The treatment planned was root canal treatment of 12,11 and 21 followed by pre-fabricated fiber post and core in relation to 11 and custom cast post in relation to 21 and rehabilitation with full ceramic prosthesis. Aesthetic reshaping and non-vital bleaching in relation of tooth 12 are also planned.

Following this, 37.5% hydrogen peroxide (pola office ultradent, USA) bleaching agent was placed immediately in the pulp chamber and dry cotton was tightly placed over this, the access cavity was sealed with temporary restoration. The patient was recalled after 1 week for assessment. Discoloration of 12 was completely removed and shade of the tooth was enhanced. (Fig 3b) The hydrogen peroxide mixture was removed from the pulp chamber using abundant saline and the access cavity was sealed with composite resin restoration. Patient did not experience any post-operative symptoms.

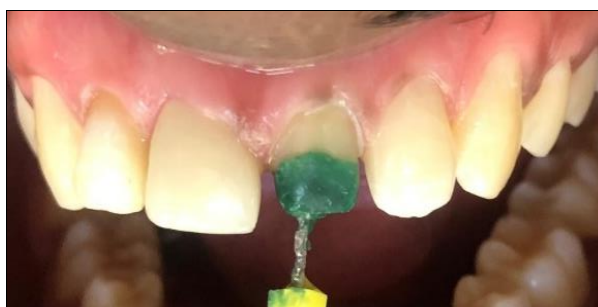
Fig 4a: Wax pattern for cast post and core on 21

Post space preparation of 21 was done with peeso reamer size #3 in the next appointment, leaving 5 mm of gutta-percha at apical end of the root canal to maintain a good seal. Tooth preparation was made with shoulder finish line on the labial and palatal sides in relation to 21. Metallic posts were fabricated using an indirect technique. A separating media was applied to the prepared post space, and an impression of tooth 21 was fabricated using inlay wax (GC Corp, Tokyo, Japan). (Fig 4a) A temporary crown was cemented before dismissing the patient. The wax pattern was then cast into the metal post and core. The fabricated cast metal post and core for 21 was cemented using zinc-phosphate cement (Prevest Denpro, USA), and an elastomeric impression was made. (Fig 4b,6b) The shade selection was done in natural daylight. The Zirconia crown was made for 21 and cemented with resin cement (RelyX U200, 3M ESPE AG, Germany) (Figure 6b).

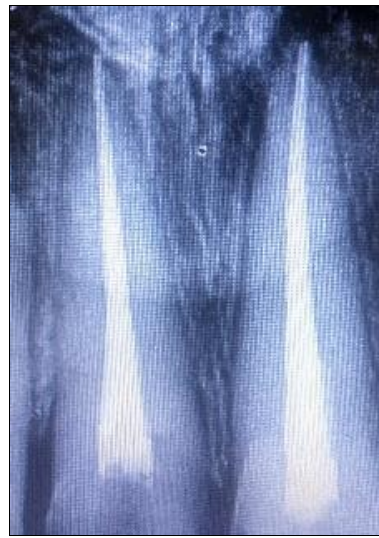
**Fig 5b:** Obturation of 11 and 21

The patient was asked to visit after 10 days. Intracanal medicament was removed. Final irrigation was carried out with 2% chlorhexidine (Asep-RC, Anabond, India). Obturation of 12,11 and 21 was completed with gutta-percha (Densply, Maillefer Switzerland) and AH plus sealer (Dentsply, Konstanz, German) using the lateral compaction technique. (Fig 5b)

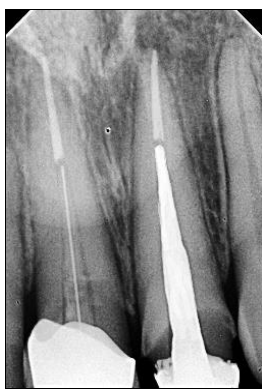
**Fig 6a:** Post operative radiograph

Follow-up examinations over 3 months revealed that the patient was asymptomatic and radiographic examination showed signs of healing. Therefore, the definitive post-endodontic restoration of 11 with fiber post and core and that of 21 with custom cast post and crown was planned.
